TEST REPORT

Test Object: Cap and pin type glass insulator
Designation: U120BP
Manufacturer: Lviv Insulator Company Ltd.
79000 Lviv, Zelena Srt. 301
Ukraine
Tested for: Lviv Insulator Company Ltd.
Date of tests: 1st October 2012 – 20th November 2012
Tested by: VEIKI-VNL Electric Large Laboratories Ltd.
Project ID: NFL-30/2012/A1
Order/Contract: NFL-30/2012, 27th July 2012
Test Specification: IEC 60383-1:1993
IEC 60437:1997
IEC 60797:1984
IEC 61211:2004
IEC 61467:2008
IEC 60060-1:1989
Tests Performed: The test object, constructed in accordance with the description, drawing and photographs incorporated in this report has been subjected to tests.
Test Results: The test object passed the test.

Test Object:	Cap and pin type glass insulator
Designation:	U120BP
Manufacturer:	Lviv Insulator Company Ltd.
Creepage distance:	445 mm
Spacing:	146 mm
Diameter of the insulating part:	280 mm
Dry lightning impulse withstand voltage:	
One unit:	125 kV
5 units:	465 kV
Wet power frequency withstand voltage:	
One unit:	50 kV
5 units:	180 kV
Puncture voltage:	130 kV
Specified mechanical failing load (SML):	120 kN
Residual strength	96 kN

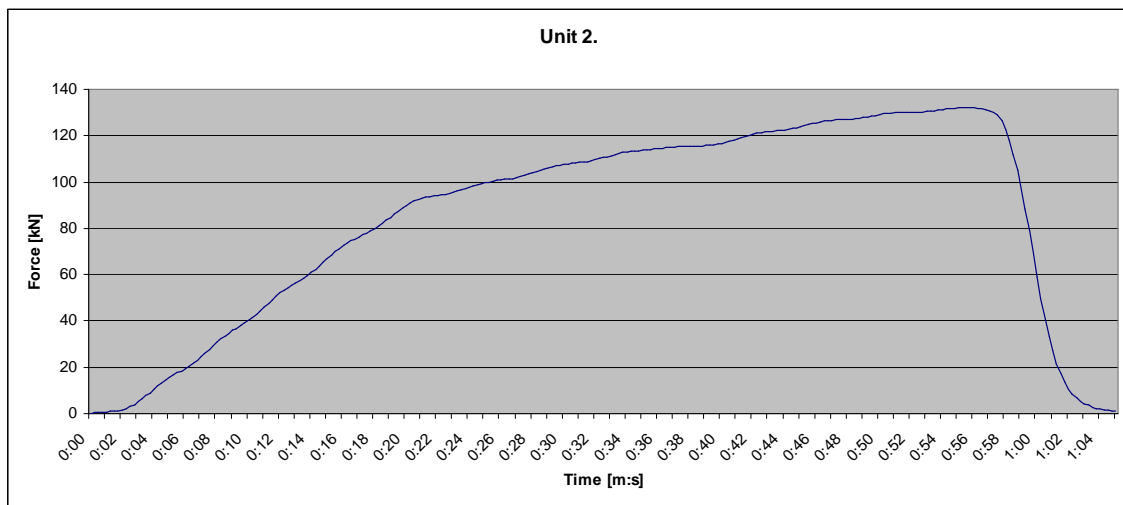
Failure was not occurred during the tensile load test at 100% of the SML (120 kN). Test were performed on samples E1 (4 insulator units), the insulators were broken at load between 131 and 151 kN. The test procedure can be seen on Diagram 2 and on Photo 4. The results are summarized in Table 6. The insulators passed the test.

The tensile load was increased rapidly but smoothly from zero to app. 75% of SML and then gradually increased in a time between 15 s to 45 s. Finally the tensile load of the insulators was measured.

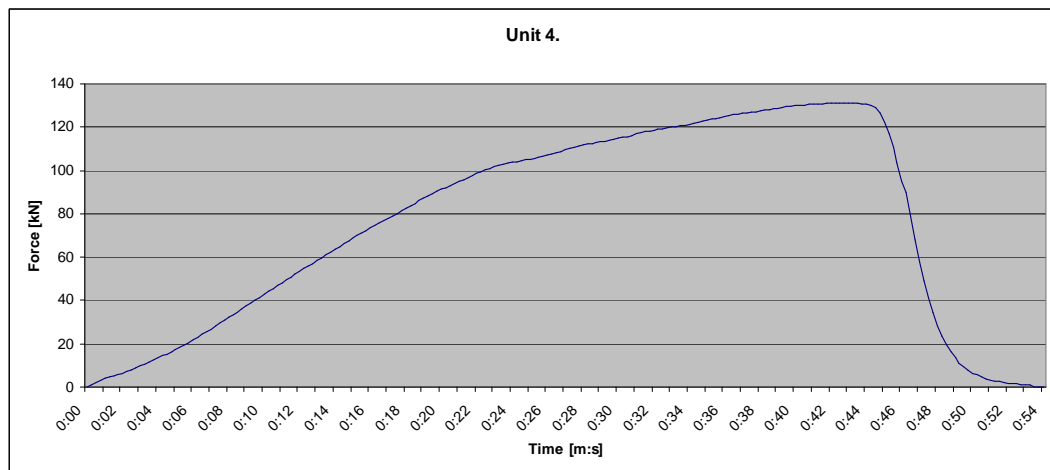
Failure was not occurred during the tensile load test at 100% of the SML (120 kN). Test were performed on 10 insulators, the insulators were broken at load between 130 and 151 kN. The test procedure can be seen on Diagram 3 and on Photo 4. The results are summarized in Table 8. The insulators passed the test.

The tensile load was increased rapidly but smoothly from zero to app. 75% of SML and then gradually increased in a time between 15 s to 45 s. Finally the tensile load of the insulators was measured.

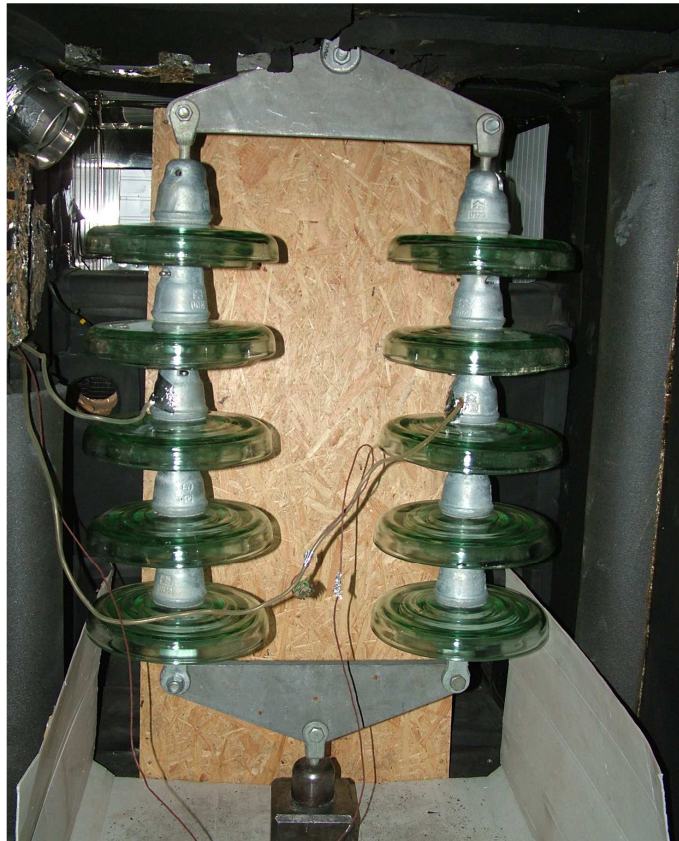
Photo 3
The test arrangement of thermal-mechanical test

The thermal-mechanical test was performed on 10 insulators. The test consisted of four cycles, where one cycle was 12+12 hours ($-30 \pm 5^{\circ}\text{C}$; $+40 \pm 5^{\circ}\text{C}$). The applied tensile load was 62.5 % of the SML. The test arrangement can be seen on Photo 3.

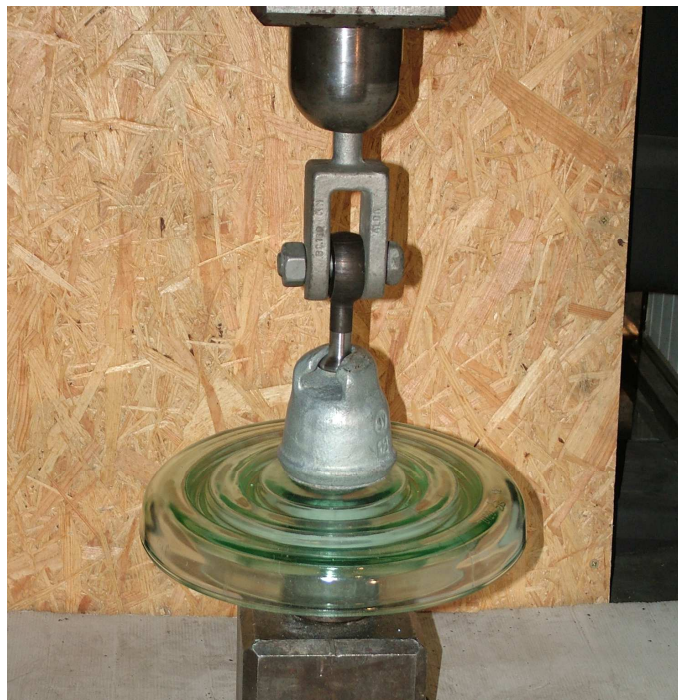
Photo 4
The test arrangement of failing load tests

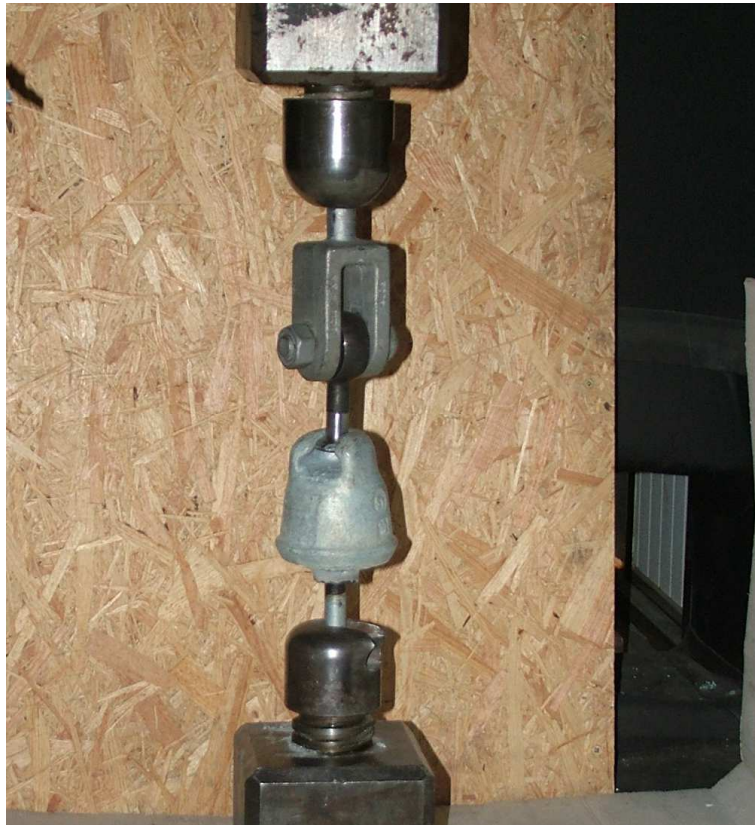
Photo 5
The test arrangement of the residual test

Failure did not occur during the temperature cycle test. The metal parts of insulators were broken at loads between 120 kN and 139 kN. The test arrangement is shown on Photo 5. The test procedure can be seen on Diagram 4. The results are summarized in Table 10 and can be seen on Photo 6. The insulators passed the test.

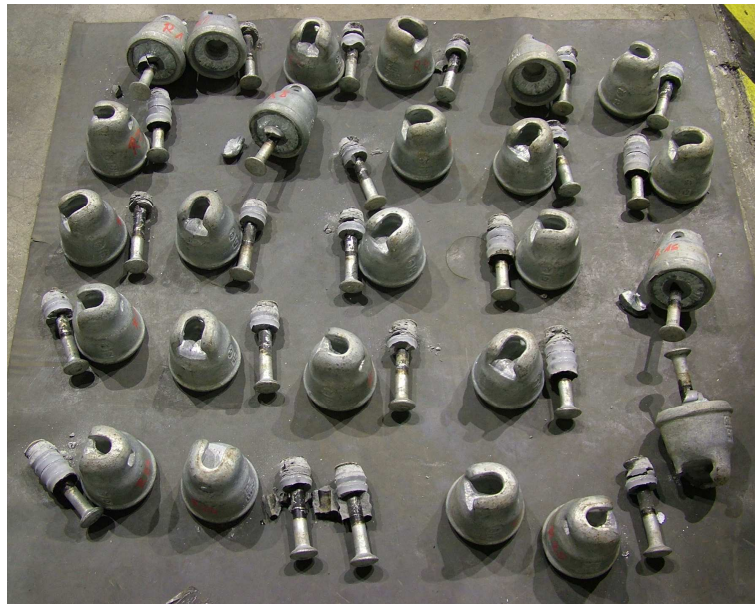
Photo 6
The broken insulators after the residual strength test

Unit No.	Mechanical failing load (kN)		Fracture pattern
	All pieces	Without broken pieces	
1R	135		Broken cap
2R	135	135	Pin pulled out
3R	130	130	Pin pulled out
4R	133	133	Pin pulled out
5R	132	132	Pin pulled out
6R	133	133	Pin pulled out
7R	129	129	Pin pulled out
8R	127		Broken cap
9R	129	129	Pin pulled out
10R	137	137	Pin pulled out
11R	131	131	Pin pulled out
12R	131	131	Pin pulled out
13R	123	123	Pin pulled out
14R	139	139	Pin pulled out
15R	123	123	Pin pulled out
16R	135	135	Pin pulled out
17R	133		Broken cap
18R	133	133	Pin pulled out
19R	120	120	Pin pulled out
20R	139	139	Pin pulled out
21R	136		Broken cap
22R	128	128	Pin pulled out
23R	128	128	Pin pulled out
24R	134	134	Pin pulled out
25R	137	137	Pin pulled out
Average (X)	131.6	131	Acceptance criteria $k \geq 0.65$ $0.76 > 0.65$ passed
Deviation (σ)	4.9	5.08	
Constant (k)	1	0.76	
(X - 1.645 σ)/SML

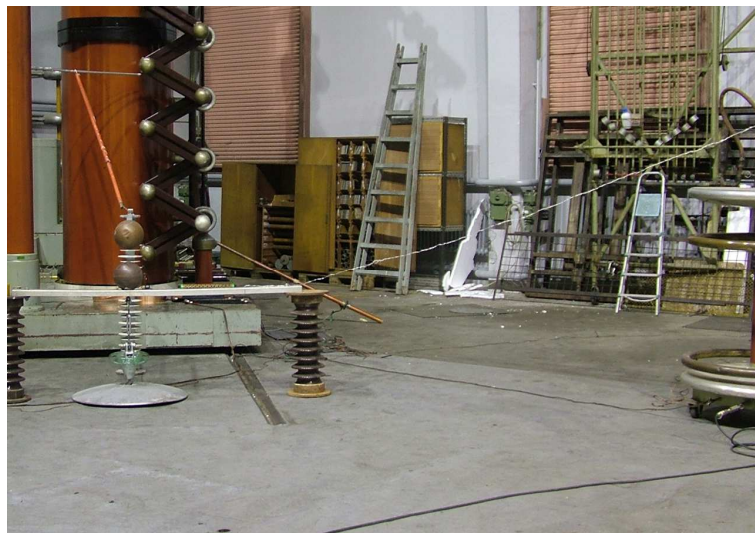
Photo 10
The test arrangement of the puncture test in air

The 50% flashover voltage value on 1 short standard string (5 units) was determined with up and down test method. After the up and down test method the 50% flashover voltage was dividing by the number of units, and the results was multiply with 2.8 p.u. A series of 10 positive and 10 negative impulses were applied on 1 insulators, with a time interval of 1,5 minute (shown in the attached oscillogram No: 9340; 9350; 9360; 9370; 9380; 9390; 9400; 9410; 9420; 9430). Tests were performed on 5 insulators. The steep front of wave test arrangement is shown on Photo 10.

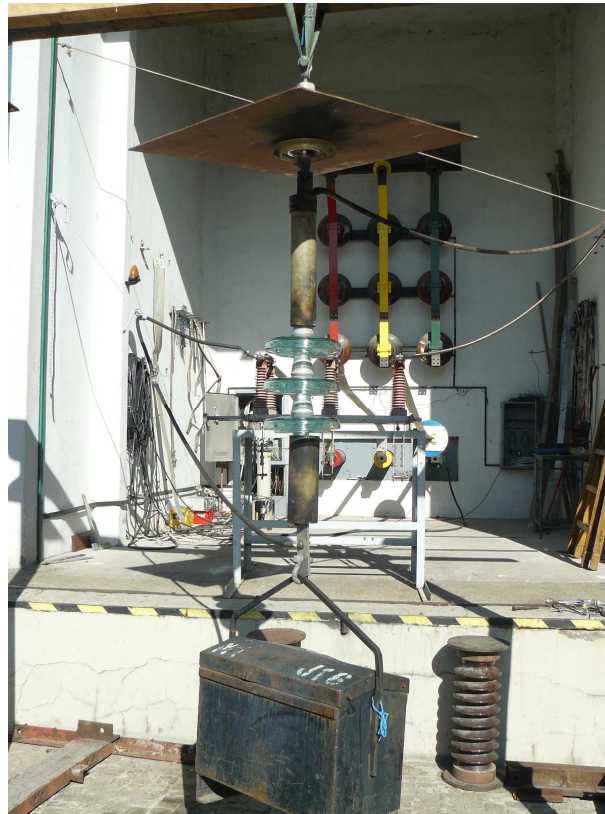
Photo 11
The test arrangement of power arc test

Name of the tests	Figures, Photos, Diagrams	Results
1. Power arc tests on insulator string (3 glass units / string) with parameters of 6 kA – 0.2 s; 6 kA – 0.2 s; 6 kA – 0.2 s	Figure 1 Photos 11-15	PASSED (details in Table 12)
2. Visual examination		
3. Mechanical failing load tests were carried out on the tested strings according to the IEC 61467:2008 standard. (70% of SML)	-	PASSED
4. Checking of dimensions	-	PASSED

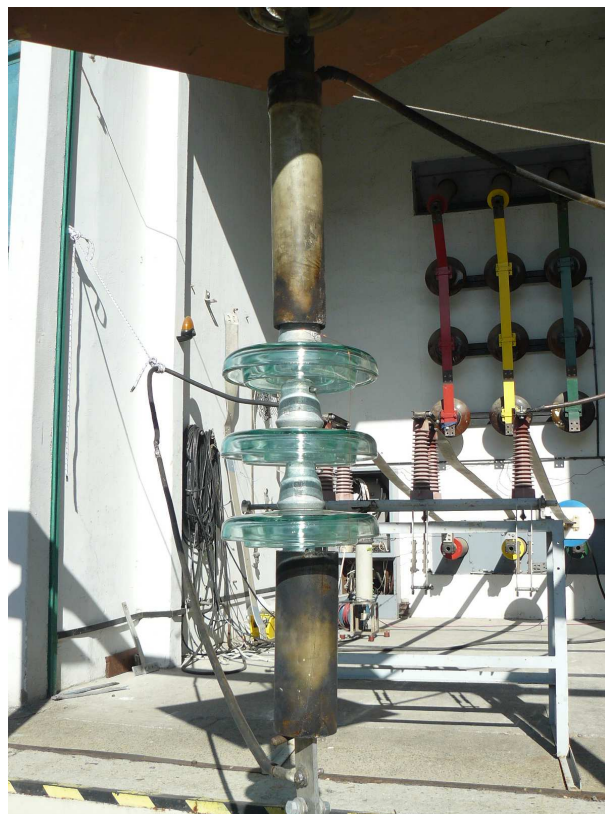
Photo 12
The first insulator string prepared for the power arc test

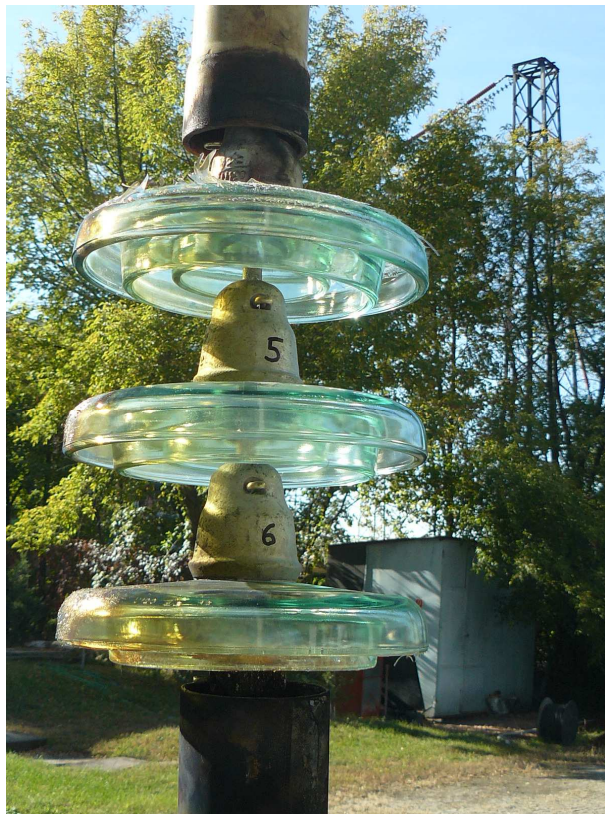
Photo 14
The second insulator string after the power arc test

humidity [%]:	56	56	56
rainfall:	-	-	-
Remarks and results: <ul style="list-style-type: none"> - After the power arc test all tested insulator passed the mechanical failing load test with 70% of SML - Neither breakage of sheds nor separation could be observed after the tests.

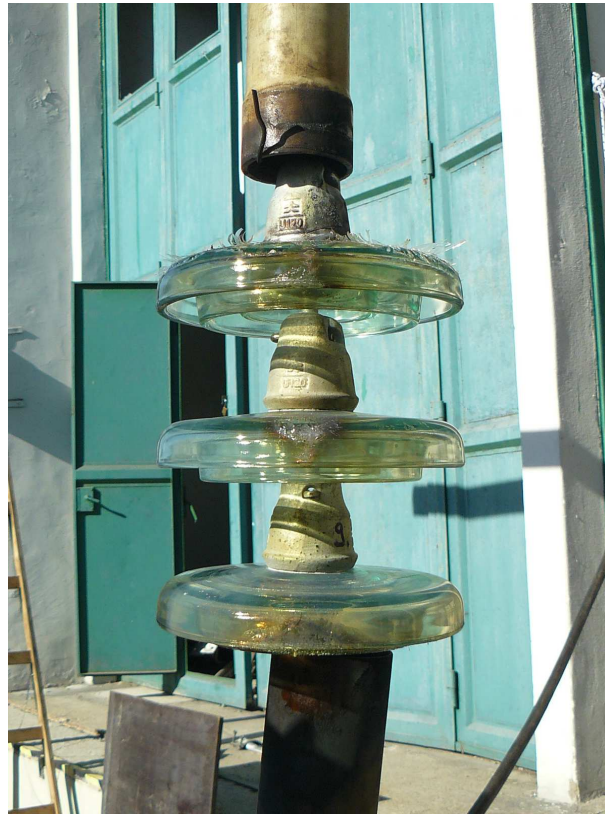
Photo 15
The third insulator string after the power arc test
